11. TITLE (Include Security Classification) Rehabilitation of Navigation Lock Walls: Case Histories					
12. PERSONAL AUTHOR(S) McDonald, James E.					
13a. TYPE OF REPORT Final Report	13b. TIME COVERED FROM TO	14. DATE OF REPORT (Year, Month, Day) December 1987		15. PAGE COUNT 316

means for removing large quantities of concrete. Once the deteriorated concrete has been removed, conventional cast-in-place concrete has been used as the replacement material in most lock wall rehabilitation projects. Other replacement systems that have been used or proposed include shotcrete, preplaced-aggregate concrete, and precast concrete stay-in-place forms. In addition, several materials including latex-modified concrete, polymer mortars and grouts, conventional shotcrete, and latex-modified, fiber-reinforced shotcrete have been used as thin overlays on existing lock walls. Applications of the various rehabilitation systems and their performance to date are described in selected case histories.

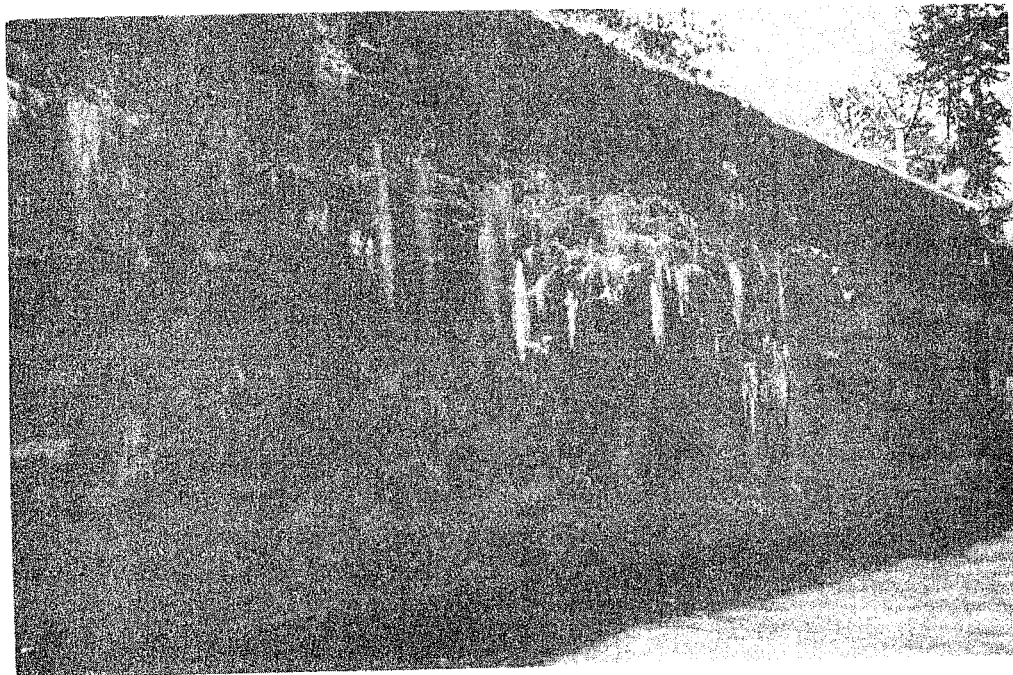
b. Close-up

23. Lock No. 5 was removed from service and, with the exception of the land wall, razed in conjunction with the construction of Maxwell Lock and Dam in 1964. A visual examination of the remaining wall in July 1985 showed that the preplaced-aggregate concrete had some cracking and leaching (Figure 3) but overall appeared to be in generally good condition after 35 years exposure.

Figure 3. Condition of land wall, July 1985,  
Lock No. 5, Monongahela River

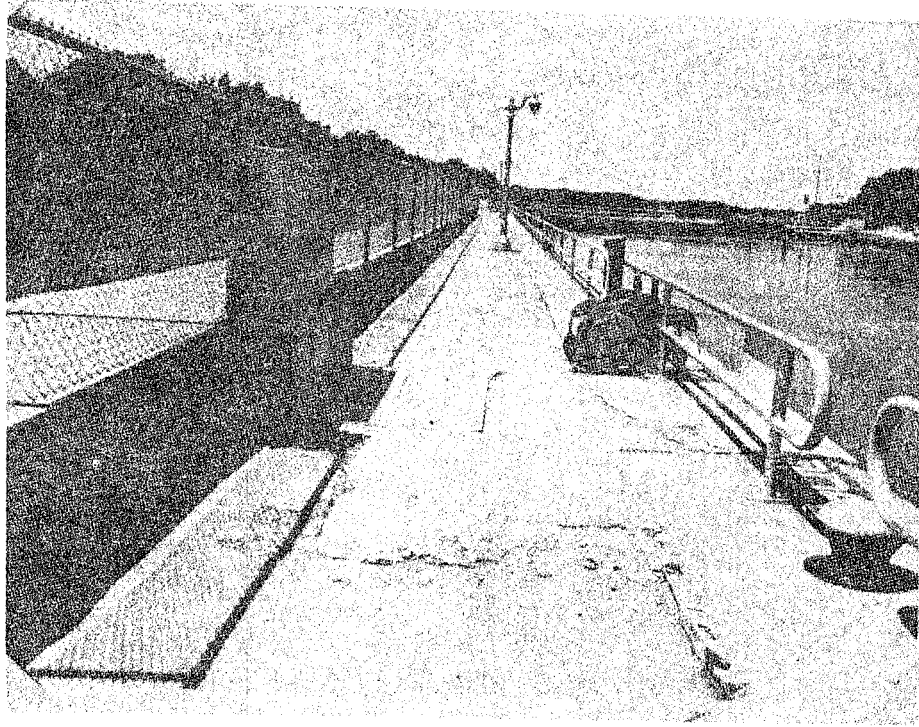
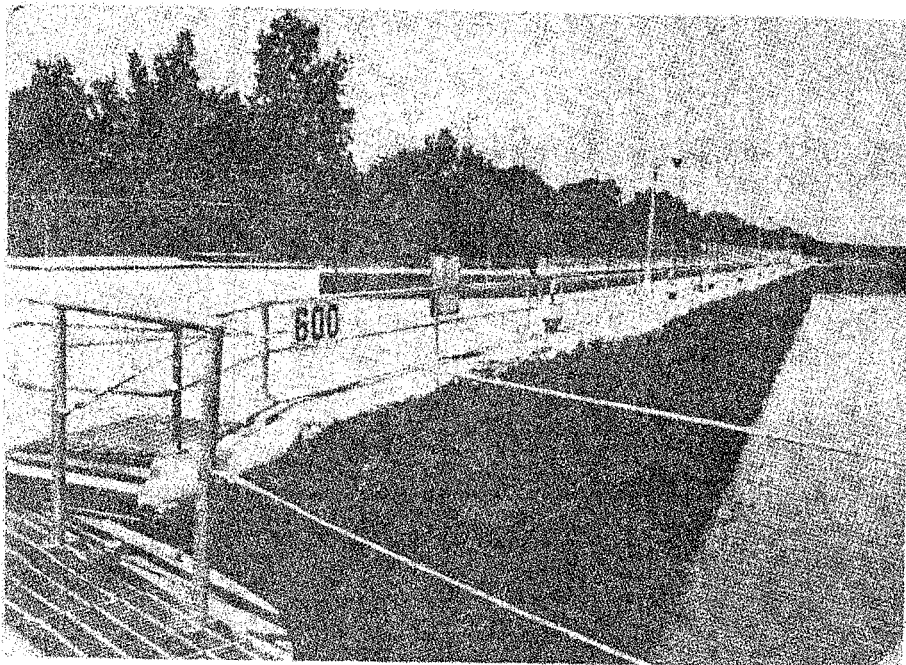
26. After almost 30 years exposure to severe weathering, horizontal concrete surfaces had scaled to an average depth of 3/4 in. Similar conditions existed on vertical surfaces, particularly at the joints. In addition, abrasion by vessels and ice had chipped concrete surfaces, particularly at upper and lower pool elevations and at the top of the wall (Figure 6). As a result, it was proposed to resurface portions of the top surface of the lock walls (Chicago District 1963). Also, portions of the vertical surfaces near the top of the walls were to be resurfaced and corner armor installed (Figure 7). This work was completed in 1965 at a cost of \$80,000.

Figure 6. Typical concrete deterioration, 1962, Marseilles Lock

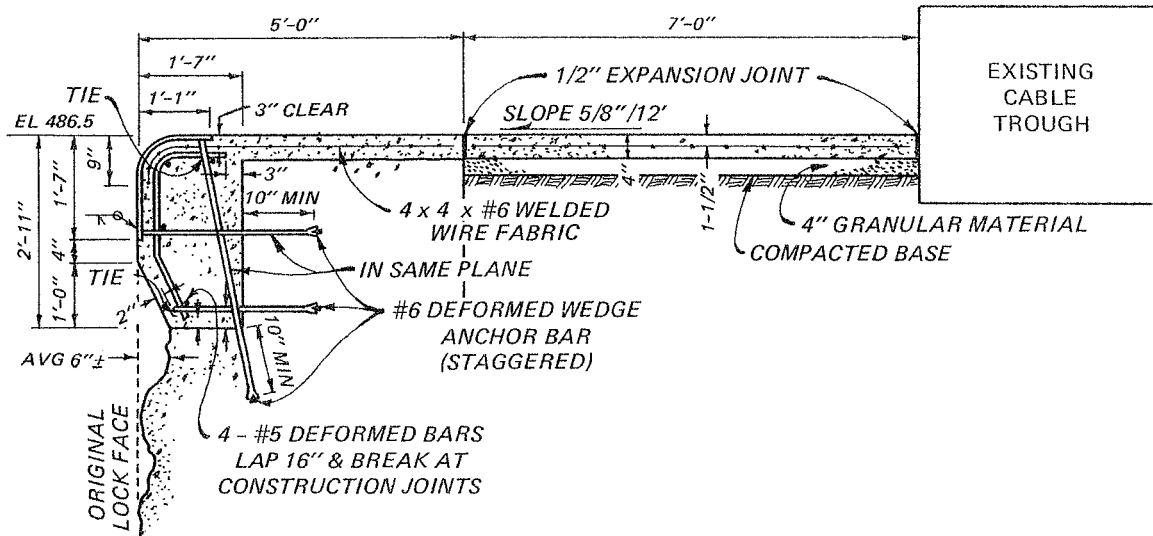
Figure 7. Typical resurfacing and corner armor installation details, 1965, Marseilles Lock

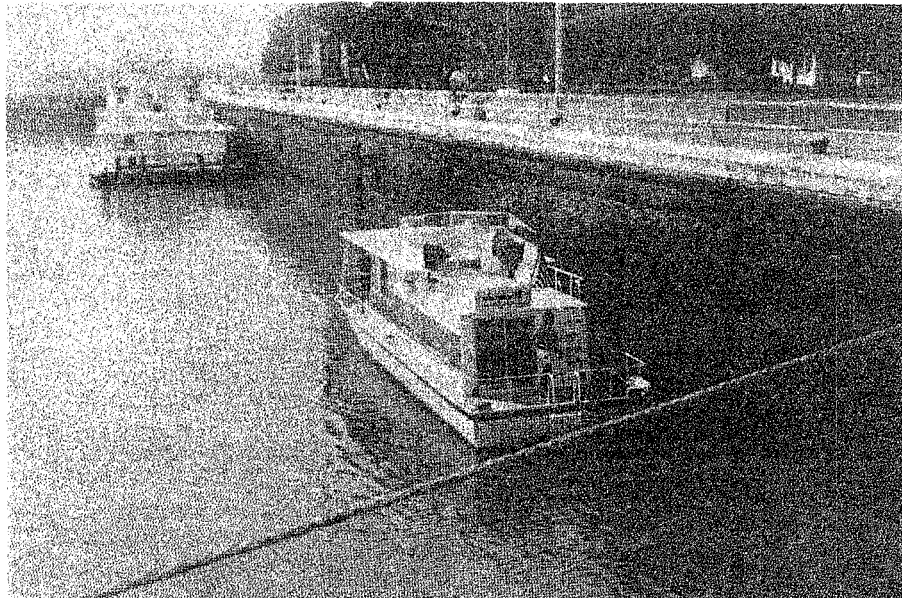
28. The second periodic inspection was conducted in August 1972. Concrete resurfacing on top of the north lock chamber wall was in good condition; however vertical surfaces were severely deteriorated, particularly at monolith joints (Figure 8). Similar conditions existed on the south wall with the addition of a few minor cracks on top of the wall. The chamber walls had eroded to the point that the downstream miter gate was vulnerable to barge

Figure 8. Severe deterioration of north lock wall, 1972, Marseilles Lock

traffic when the gate was in the open position. It was concluded that if allowed to progress, loss of section through erosion would impair the stability and integrity of the lock walls. Therefore, it was recommended that the lock chamber walls be resurfaced. Since such a repair would have to be accomplished with a minimum of lock downtime, the Office of Chief of Engineers (OCE) suggested that precast concrete stay-in-place forms be studied as a potential repair technique. The Little Rock District (1963) had investigated this system of forming for new construction, and the Bureau of Reclamation had used it in the restoration of Barker Dam (Davis 1948).

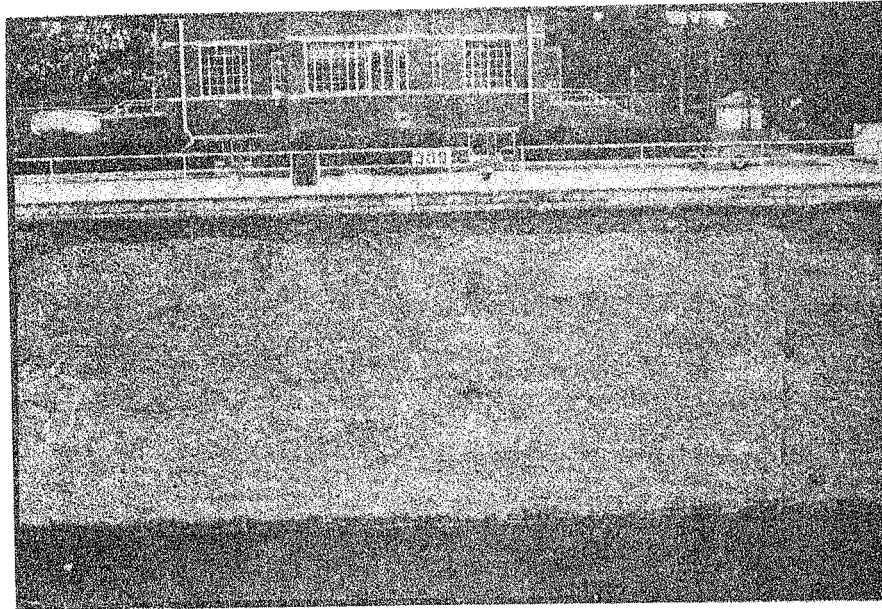
a. Monolith 31

The maximum depth of erosion (1.10 ft) was measured in a few isolated areas. The surface of a typical monolith (31) is shown in Figure 9, and the results of the survey on the monolith are shown in Figure 10. Erosion of the concrete ranged from slightly above low pool elevation to approximately 2 ft below the top of the wall with the most severe erosion in the upper portion of the walls.

Figure 9. Typical concrete conditions, 1973,  
Marseilles Lock

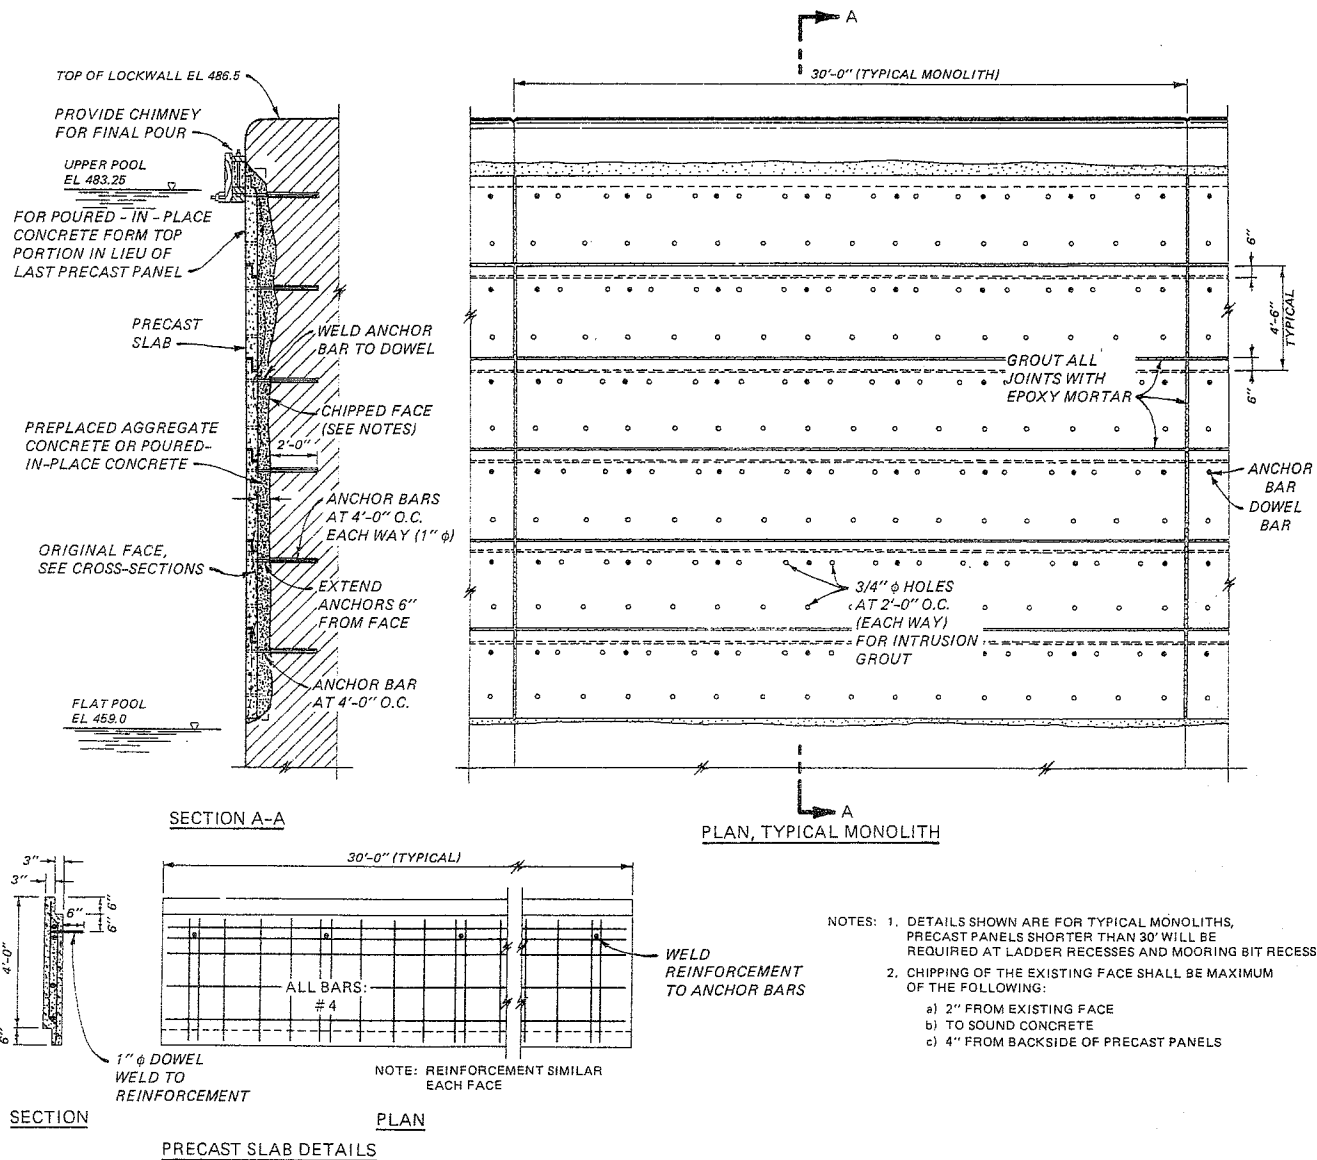
Figure 12. Lock wall resurfacing using precast panels, Marseilles Lock

- a. Shotcrete. Pneumatic application of concrete to lock surface by either dry or wet process.
- b. Precast Panels with Cast-in-Place Concrete. The method consists of anchoring 4-in.-thick precast panels and placing concrete in the space between the panels and the existing lock wall by conventional methods (Figure 12).
- c. Precast Panels and Preplaced Aggregate Concrete. Same as b above, except the space between the panels and the lock walls is filled by preplaced aggregate concrete.
- d. Conventional Concrete. In this method, forms are erected and concrete is placed by the tremie method.
- e. Preplaced Aggregate Concrete. In this method, the space between the forms and the lock walls is filled with preplaced aggregate concrete.

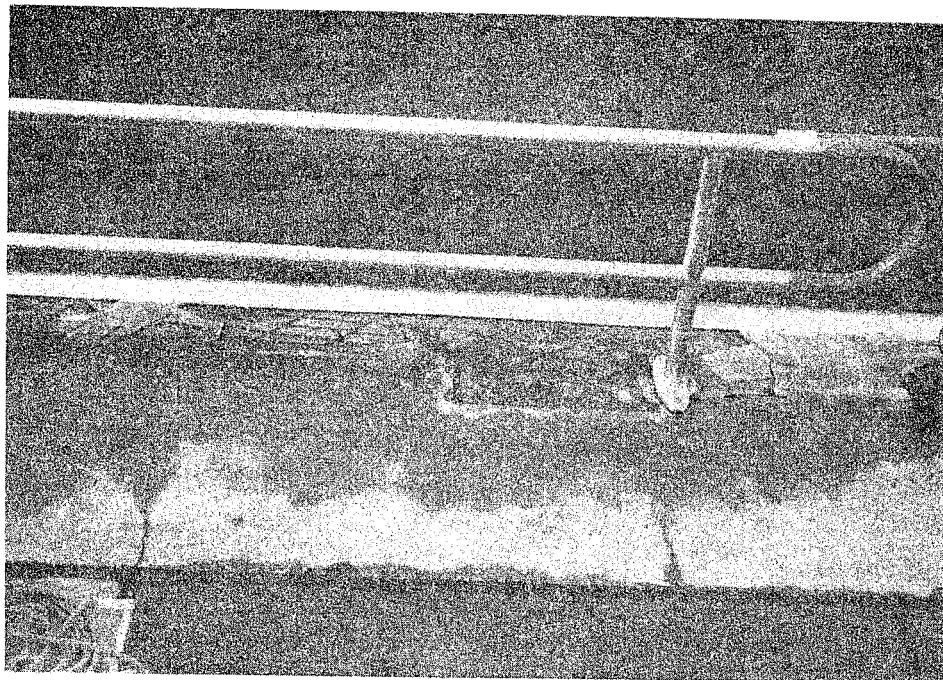
43. The epoxy layer at the top of the lock also delaminated (Figure 15). A large percentage of the epoxy overlay has spalled off, is cracked, or has disintegrated. A large thermal coefficient of expansion of the epoxy mortar as compared to that of the concrete is the most likely cause of failure.

Figure 15. Typical delamination of epoxy overlay, May 1985, Marseilles Lock

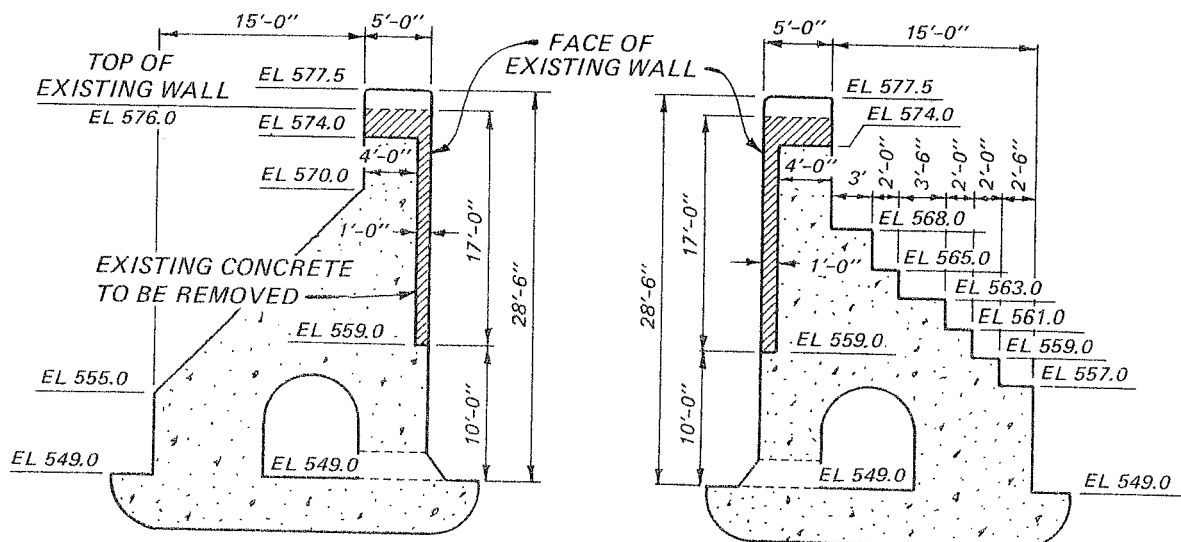
Figure 21. Typical sections showing extent of concrete removal and replacement, Old Lock No. 14, Mississippi River

51. Concrete deterioration on vertical surfaces was generally confined to those areas of the lock walls above low water level (Figure 20). Therefore, concrete removal and replacement was confined to the top 17 ft of the walls except for the outer gate monoliths where extensive concrete removal was necessary to accommodate new gates and operating machinery (Rock Island District 1980). Twelve inches of concrete was removed from the vertical face of the walls, and two feet of concrete was removed from the top of the walls (Figure 21).

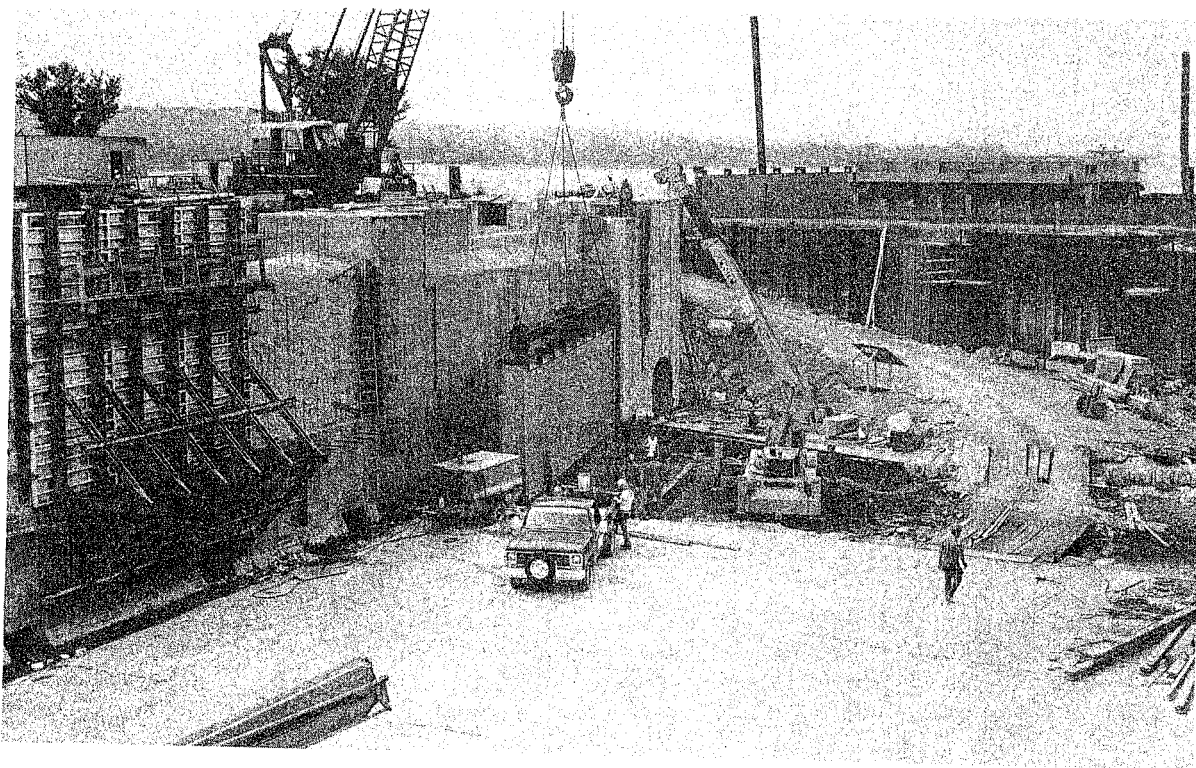
Figure 23. Concrete forming system and gate installation,  
August 1980, Old Lock No. 14, Mississippi River

54. The replacement concrete was anchored to the existing concrete by No. 6 dowels spaced 4 ft on centers. The dowels were grouted into the existing concrete using prepackaged polyester resin grout cartridges. A reinforcing mat, No. 6 bars on 12-in. centers each way, was placed near the face of the replacement concrete for crack control. Forms for the new concrete were attached to the existing wall (Figure 23).

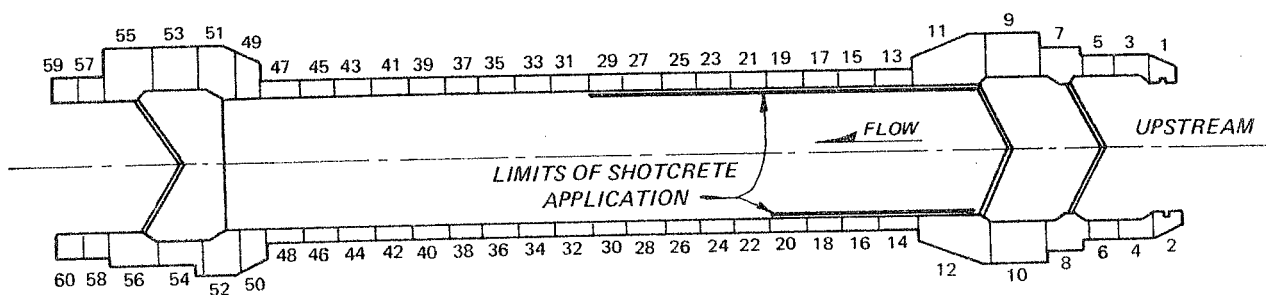
Figure 26. Wall monoliths that were refaced with shotcrete, 1954, Dresden Island Lock

61. In 1954, deteriorated portion of the lock chamber walls and the gate bays of the upper and lower service gates were resurfaced. Resurfacing in the lock chamber (Figure 26) extended over the even numbered monoliths 12 through 20 for the land wall and over the odd numbered monoliths 11 through 29 for the river wall. Also, portions of the back side of the river wall were resurfaced. Resurfacing consisted of removal of weathered concrete and refacing with anchored and reinforced shotcrete (Gunitite).

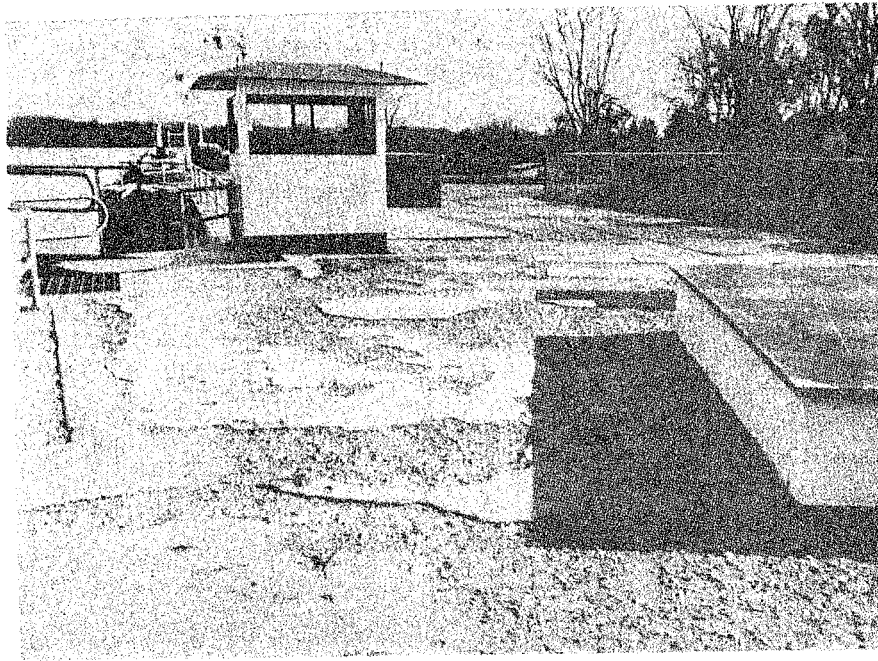
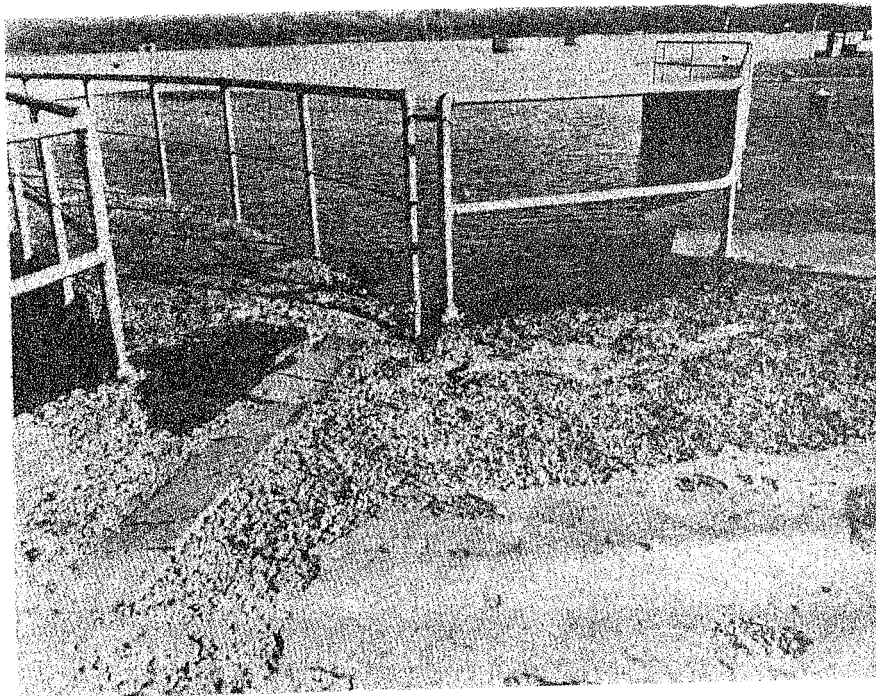
68. During the original lock construction, horizontal surfaces were finished without any slope. As a result, water ponding on these surfaces

contributed to the concrete deterioration through cycles of freezing and thawing (Figure 29). In 1961, the top surfaces and the upper 3 ft of the vertical walls of the lock were resurfaced. This repair involved removing a minimum of 4 in. of concrete and replacing with new air-entrained concrete reinforced with wire mesh. In addition, corner armor was added to the lock chamber walls.

Figure 29. Typical concrete deterioration on tops of lock walls, 1961, Dresden Island Lock and Dam

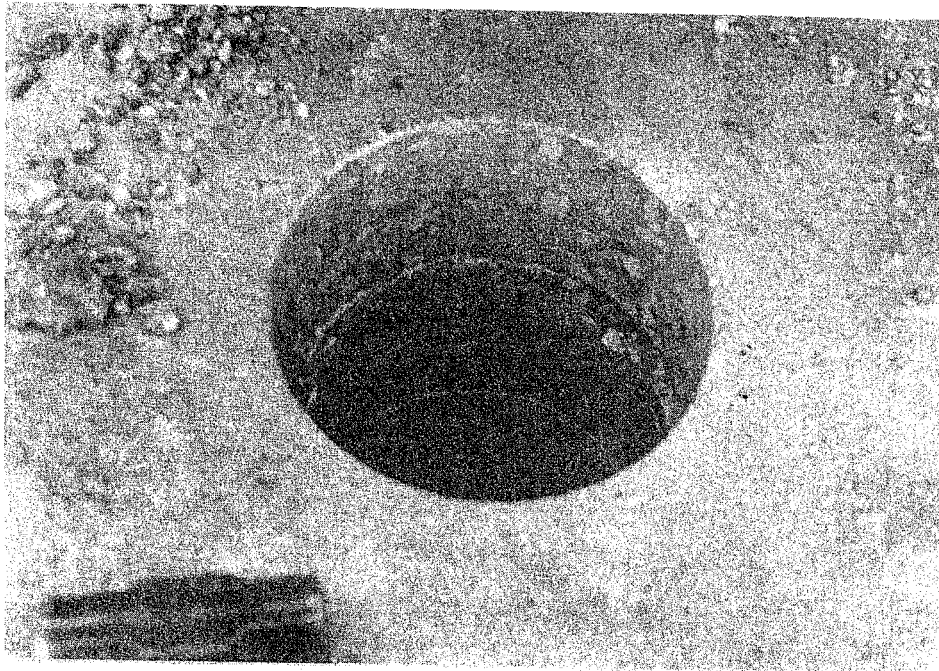
70. An extensive core drilling and laboratory testing program was conducted during 1976 and 1977 to ascertain the extent and cause of concrete deterioration (Stowe et al. 1980a). Four drill holes were located in areas that had been resurfaced with concrete in 1961. The new concrete was found to be structurally sound by itself, but in certain locations it was considered susceptible to barge impact because of the frost-damaged concrete beneath (Figure 30). The original concrete in the lock walls was nonair-entrained

Figure 30. Downhole view showing newer good quality concrete overlay and underlying deteriorated concrete, 1977, Dresden Island Lock

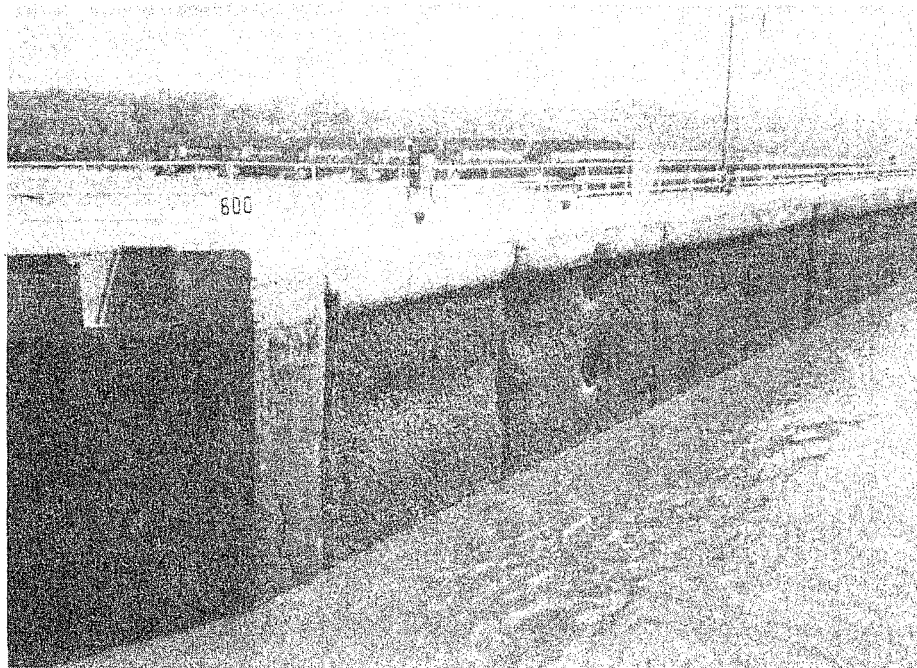
72. Deterioration of the exposed and near surface original concrete ranged from light to severe. About 80 percent of the exposed vertical surfaces of the concrete in the lock walls had been effected by frost action (Figure 31). The average depth of concrete deterioration as determined by petrographic examination were as follows: lock chamber walls, 0.7 ft; river-side of river wall, 0.9 ft; and the upper gate bays, 1.5 ft. Severe loss of concrete was evident at most monolith joints.

Figure 31. Typical concrete deterioration, 1977,  
Dresden Island Lock

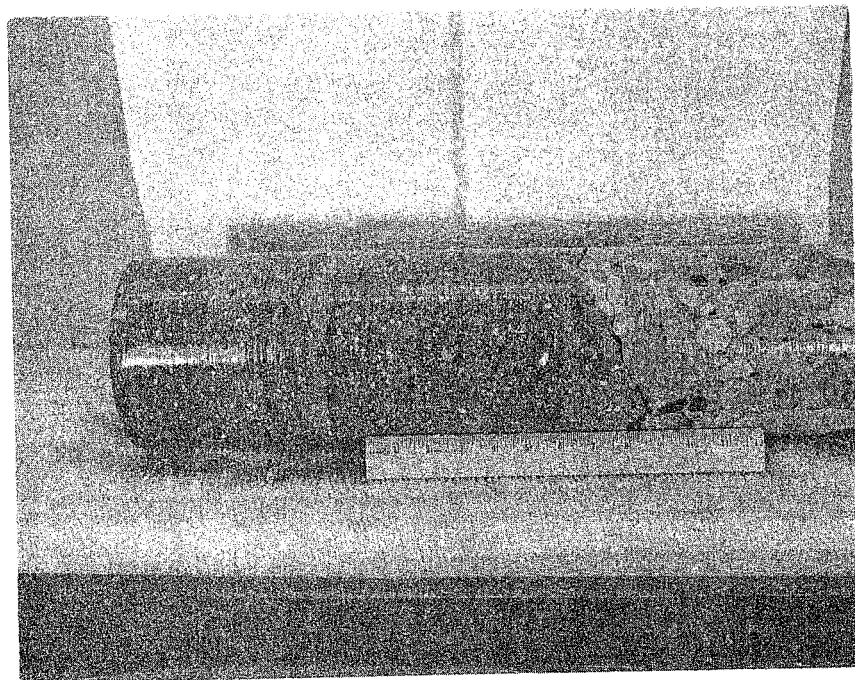
73. Three borings were drilled from inside the lock chamber into the river wall section previously refaced with shotcrete. The shotcrete had a minimum thickness of 12 in. (Figure 32) and exhibited excellent bond to the original concrete. Air-void data determined according to CRD-C 42 indicated the shotcrete had about 3 percent total air with approximately 2 percent of it in voids small enough to be classified as useful for frost resistance. The air-void spacing factors ranged from 0.010 to 0.014 in. While these values are larger than is desirable (0.008 in. is considered the maximum value for air-entrained concrete), they may have imparted some frost resistance. Also, there were no large voids or strings of voids due to lack of consolidation such as have been observed with other shotcrete specimens. Typical surface conditions of the shotcrete are shown in Figure 33.

Figure 32. Horizontal core taken through shotcrete resurfacing, 1976, Dresden Island Lock

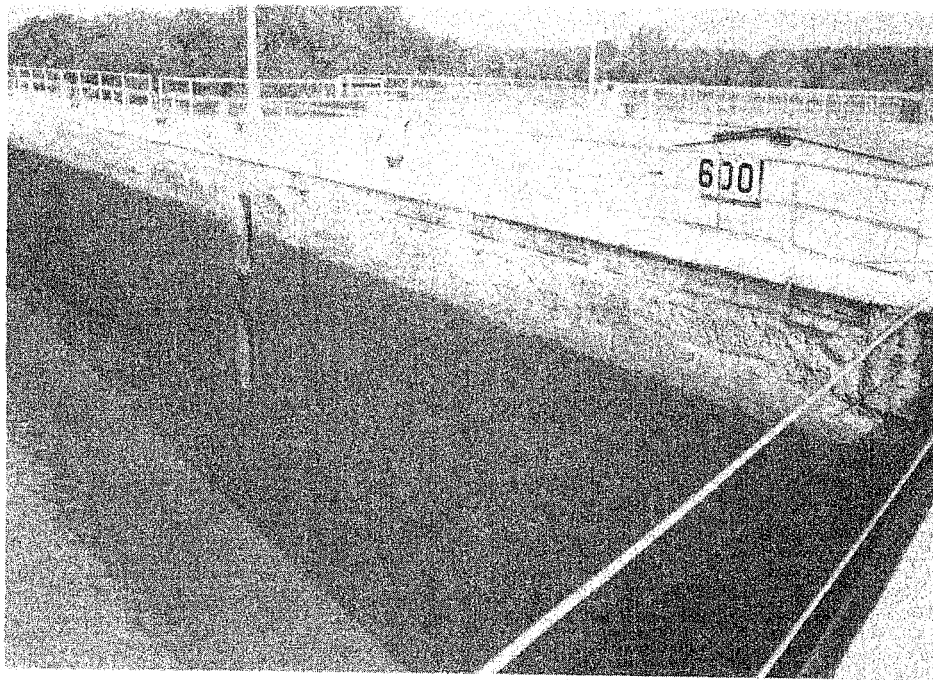
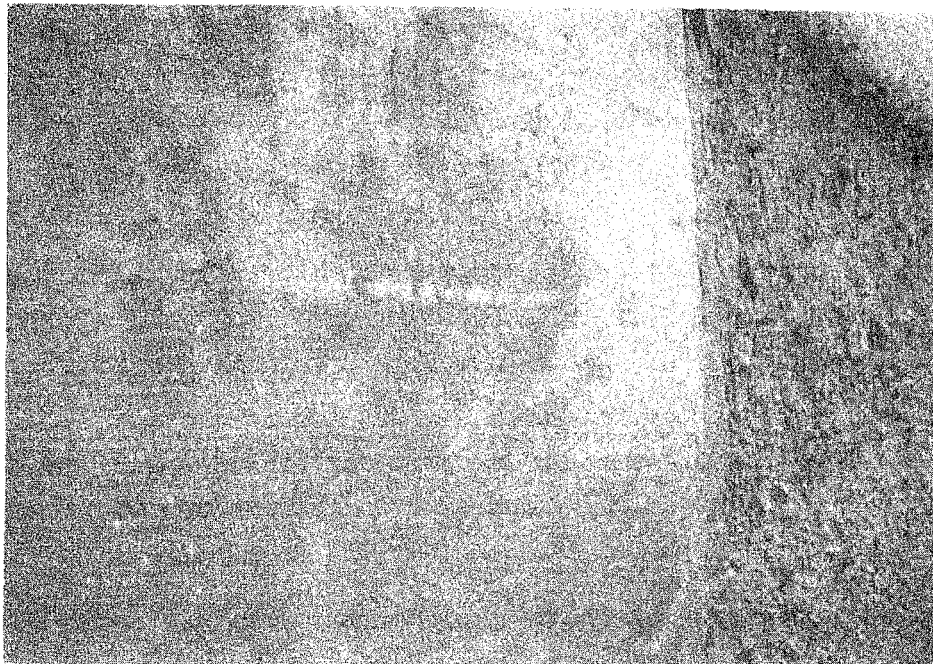
a. River wall

b. Interface between shotcrete (left)  
and original concrete

Figure 33. Shotcrete surface conditions, 1977,  
Dresden Island Lock

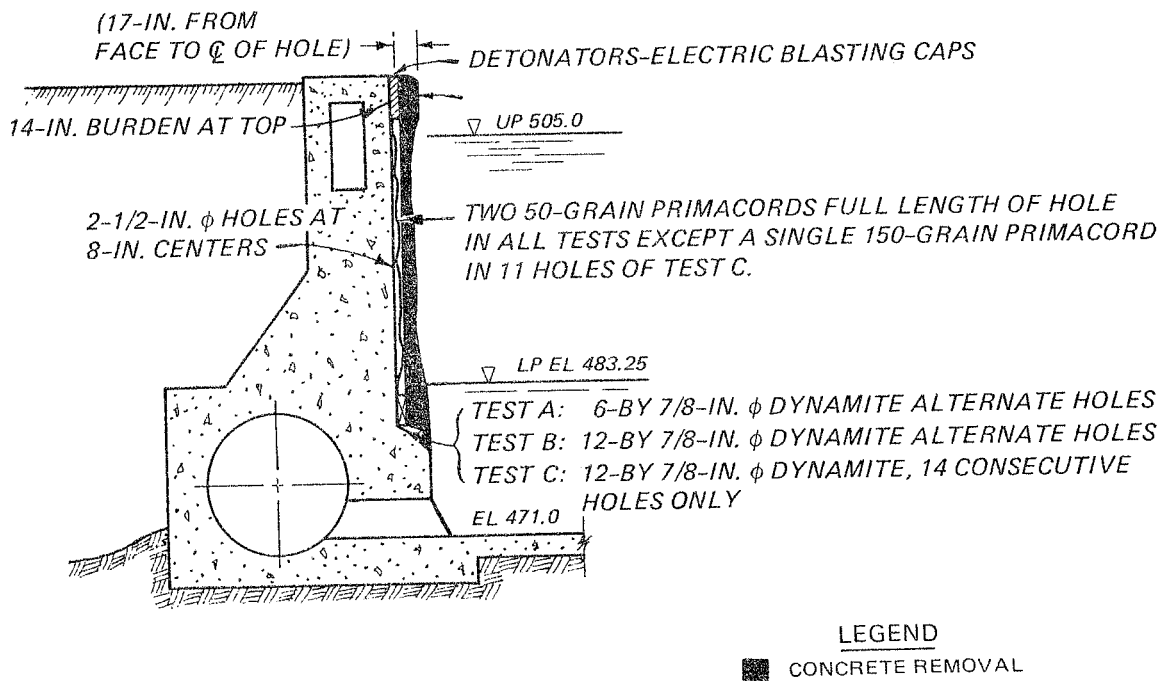
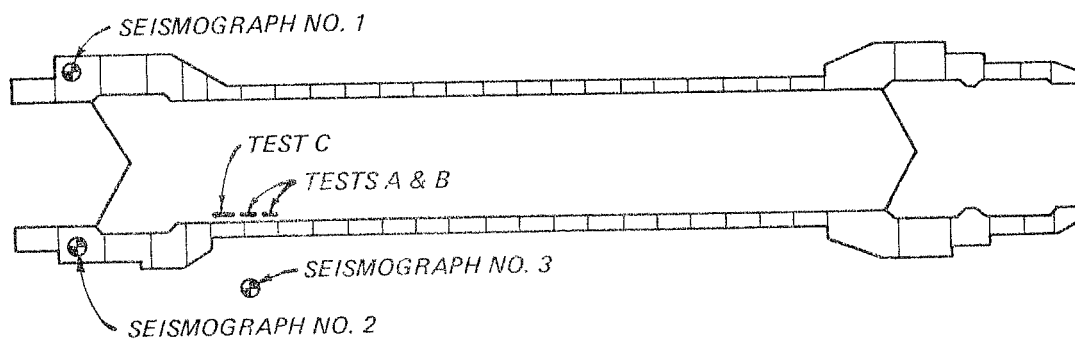
77. The contractor employed a subcontractor for blasting operations who in turn used the services of another firm for development of the blasting plan and monitoring of the blasting activities. Three test blasts were performed prior to the adoption of the plan for production blasting. The blasting plan for the three tests is shown in Figure 34. The test data are summarized as follows:

a. Type and location of explosives

b. Location of test blasts and seismographs

Figure 34. Test blasting plan, Dresden Island Lock

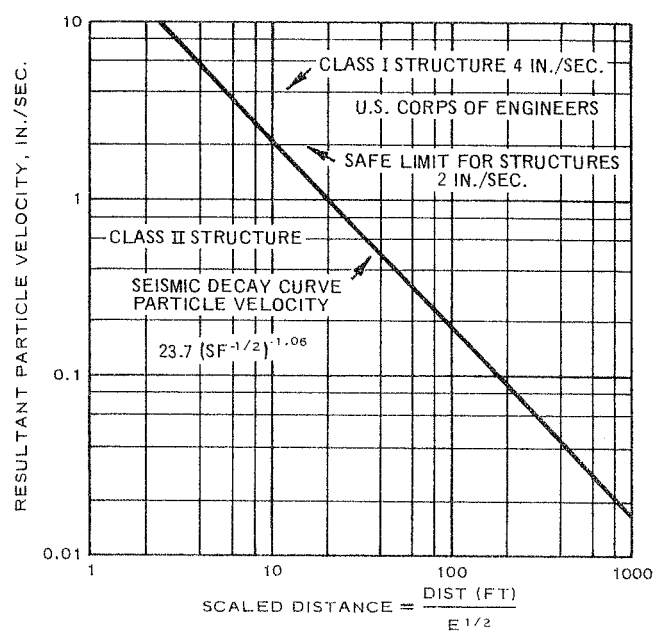
78. From the nine test points, a linear regression of particle velocity versus scaled distance was developed for guidance in production blasting (Figure 36). While all three tests produced satisfactory results, generally a clean break without cracking in the remaining structure, the size of charges and delays of test blast A were adopted for production blasting. Forty-five holes at 8-in. spacing, constituting the width of one monolith, were detonated at a time. The size of charges and delays are extremely important factors in concrete removal. In an almost identical lock resurfacing project, at Starved Rock, the contractor test blasted a 30-ft-wide monolith with 45 holes at 8-in. centers, each hole loaded with 150-grain detonating cord (no dynamite) and no delays. The results were disastrous with numerous cracks developing at corners of cable galleries and elsewhere. The contractor modified the blasting procedures by decreasing the detonating cord to 100 grain and using delays. Excellent results were obtained with the modified system (Juzenas 1980).

Figure 36. Resultant particle velocity versus scaled distance, Dresden Island Lock

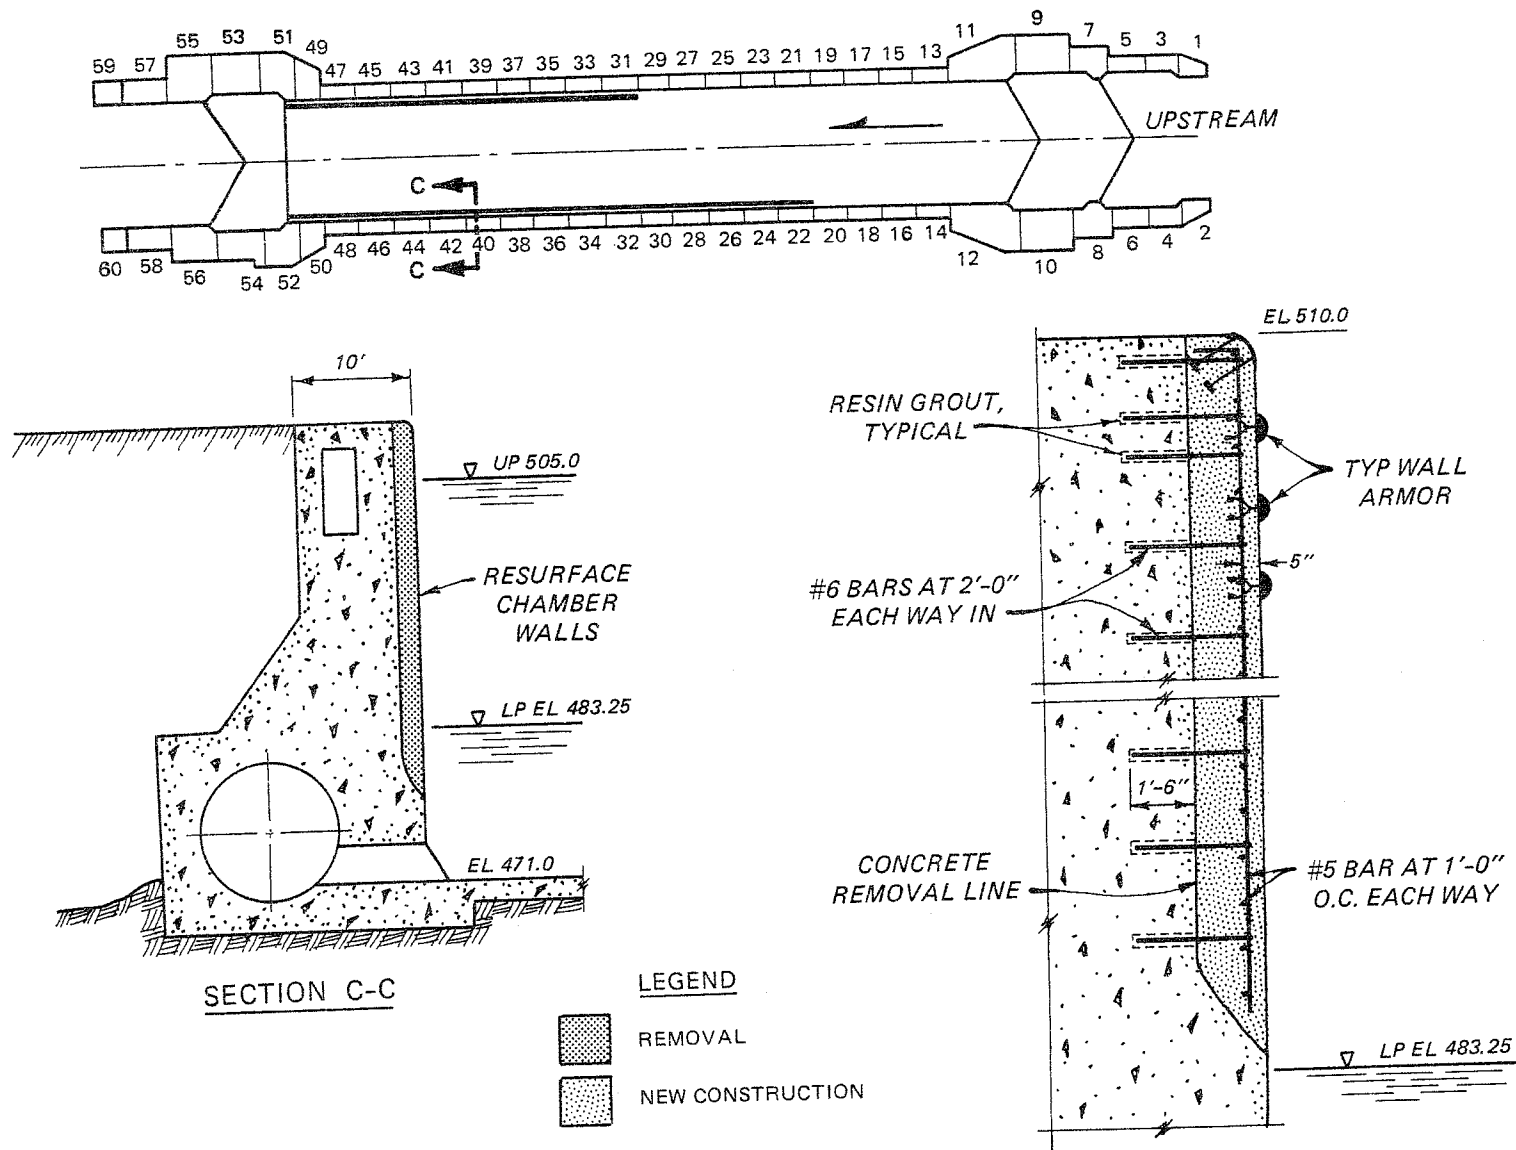
Figure 37. Land wall resurfacing, Dresden Island Lock

79. Following removal of concrete to a depth of 17 in. from the original wall surface, the lock walls were resurfaced as shown in Figures 37 and 38. Concrete anchors were No. 6 reinforcing bars spaced on 2-ft centers each way. The anchors were embedded using two-component polyester resin grout cartridges. Insertion of the anchor into the drill hole ruptured the seal between the two-component resin in the previously installed cartridge. Mixing of the grout was accomplished by spinning the anchor using an electric drill. A straight anchor bar was selected for ease in attachment to the drill chuck. The size, length of embedment, and spacing of the anchors were arbitrarily selected using engineering judgment. To assure adequate embedment of the anchors, pull-out tests were specified. Three anchors were specified to be

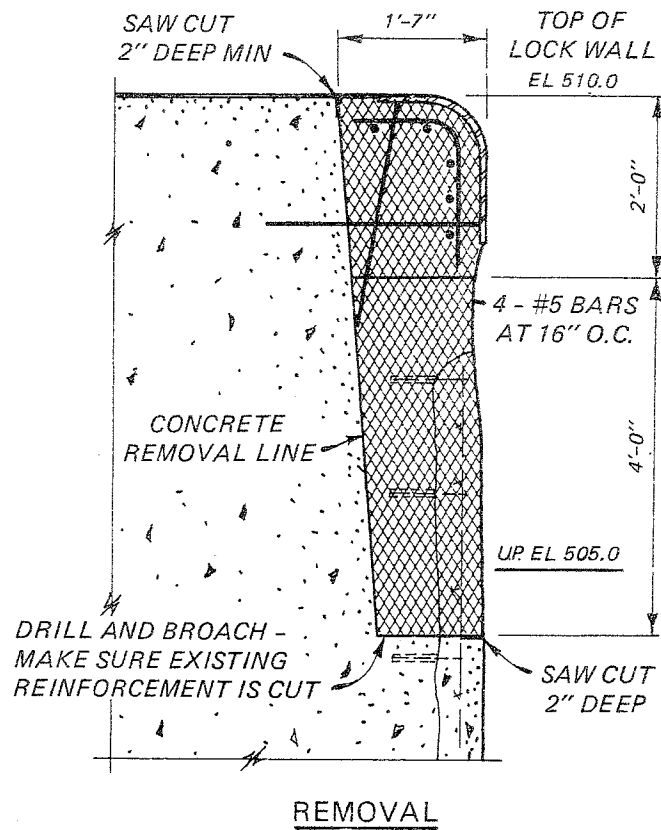
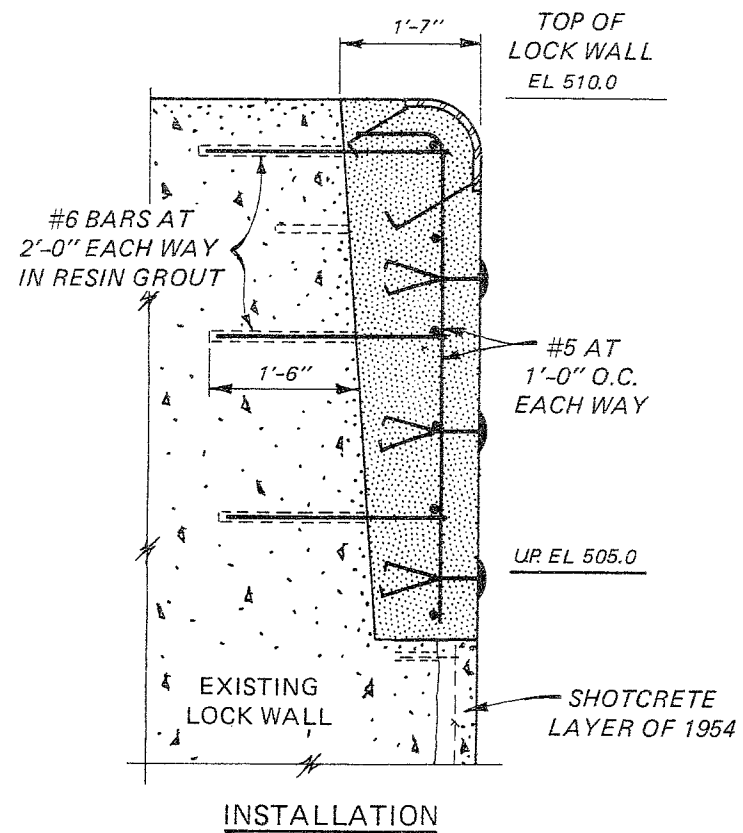
Figure 39. Armor installation in portions of lock wall previously resurfaced with shotcrete, Dresden Island Lock

82. Wall armor was installed in that portion of the lock walls previously repaired by shotcreting as shown in Figure 39. Note that at the bottom removal line drilling and broaching was specified to prevent cracking in the concrete below. Similar armor was installed in the concrete resurfacing.

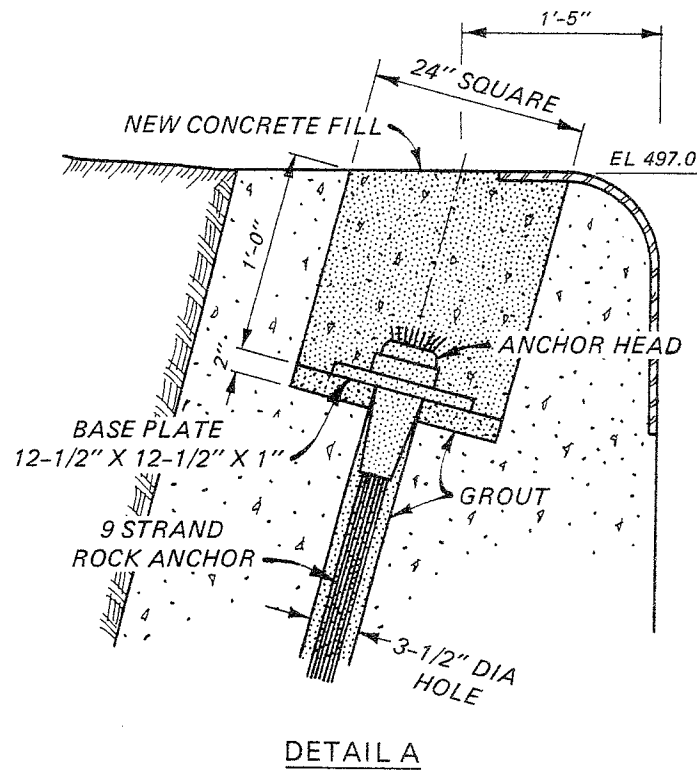
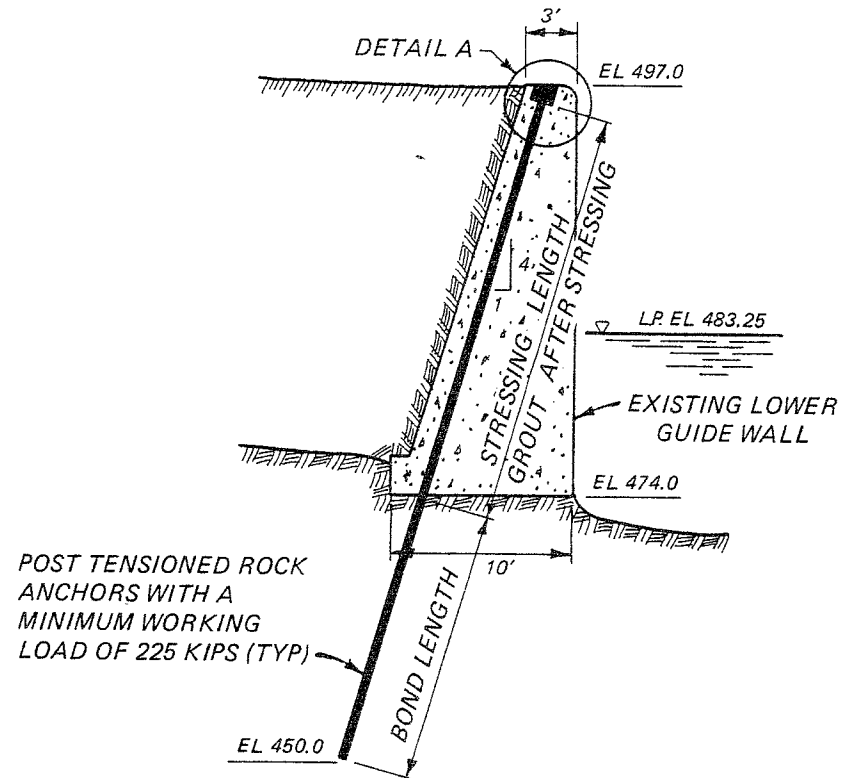
Figure 40. Lower guide wall stabilization, Dresden Island Lock

84. Calculations using conventional methods showed that the lower guide wall was usable under normal operating conditions. The fact that the wall had stood for about 40 years while the lock was in operation appeared to say something about the reliability of the analysis when performed by conventional methods. However, when analyzed by the finite element method, the wall was found to be stable with about 25 percent of the base in compression. Stabilization of the lower guide wall by posttensioned tendons was considered necessary to increase its stability against overturning. The anchors were nine-strand, seven-wire anchors, designed for 225 kips working load (Figure 40). They were spaced at about 7-1/2-ft centers. The anchors were about 48-ft long with a bonding length in rock of about 25 ft. The anchors were embedded in grout their full length.

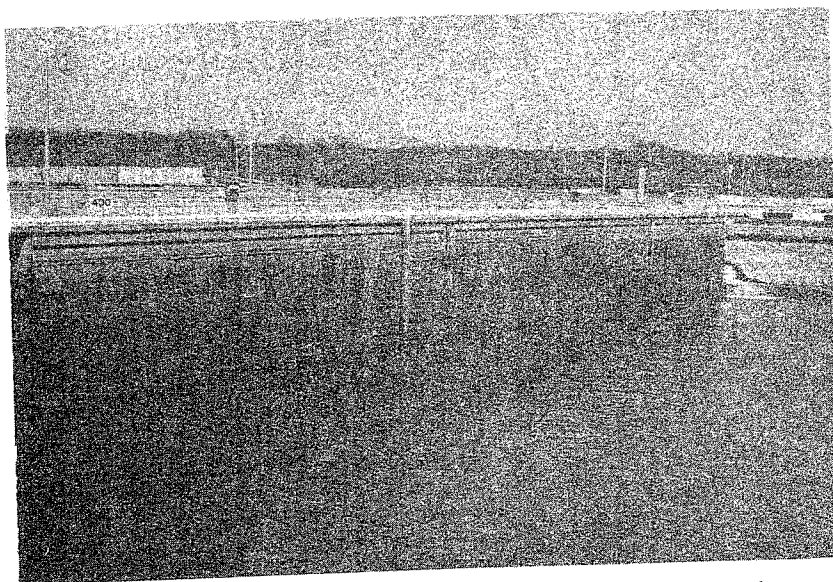
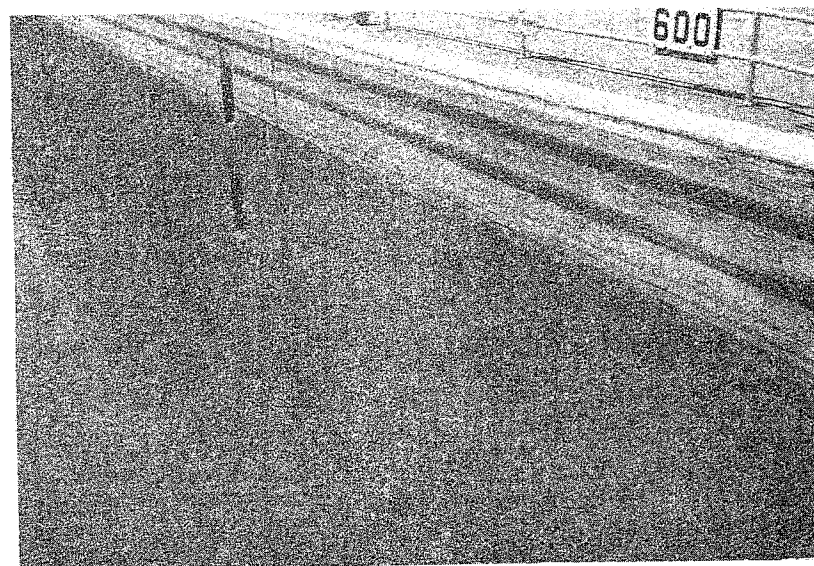
86. Although there is some minor spalling at monolith joints and at the interface between the shotcrete and the concrete placed in 1978 when horizontal armor was installed (Figure 41), overall the shotcrete remains in excellent condition after more than 30 years in service. With the exception of some isolated spalling (Figure 42), the concrete resurfacing inside the lock chamber is in good condition. Cracking previously reported in the replacement concrete has generally been obliterated by staining on the concrete surface. The concrete overlay on the back side of the river wall appears to be in generally good condition although there are a number of cracks in some areas (Figure 43). Minor seepage occurs sporadically through a horizontal cold joint located at midheight on the wall.

Figure 41. Typical condition of wall sections resurfaced with shotcrete, 1986, Dresden Island Lock
